Flootation tank associated *Pseudomonas aeruginosa* infection

Abstract: Flootation tank water contains a high concentration of magnesium sulfate (MgSO_4), which should be unfavorable to most microorganisms that are not salt tolerant. The high salt concentration also means that users of flootation tanks are more likely to shower after floating and are less likely to float with open sores, get water in their eyes, or ingest the flootation tank water. In addition, the number of daily users is relatively stable. However, despite these factors, pathogens commonly associated with pool or hot tub use can still be found in flootation tanks. A clinical case of *Pseudomonas aeruginosa* infection associated with exposure to a flootation tank was investigated by Vancouver Coastal Health. The investigation resulted in the issuance of a closure order to the operator of the facility. A clinical specimen obtained from the complainant and a water sample from the implicated flootation tank both tested positive for *Pseudomonas aeruginosa*, although, the isolates were markedly different. The possible explanations for this laboratory outcome are presented. This case study illustrates that a disruptio

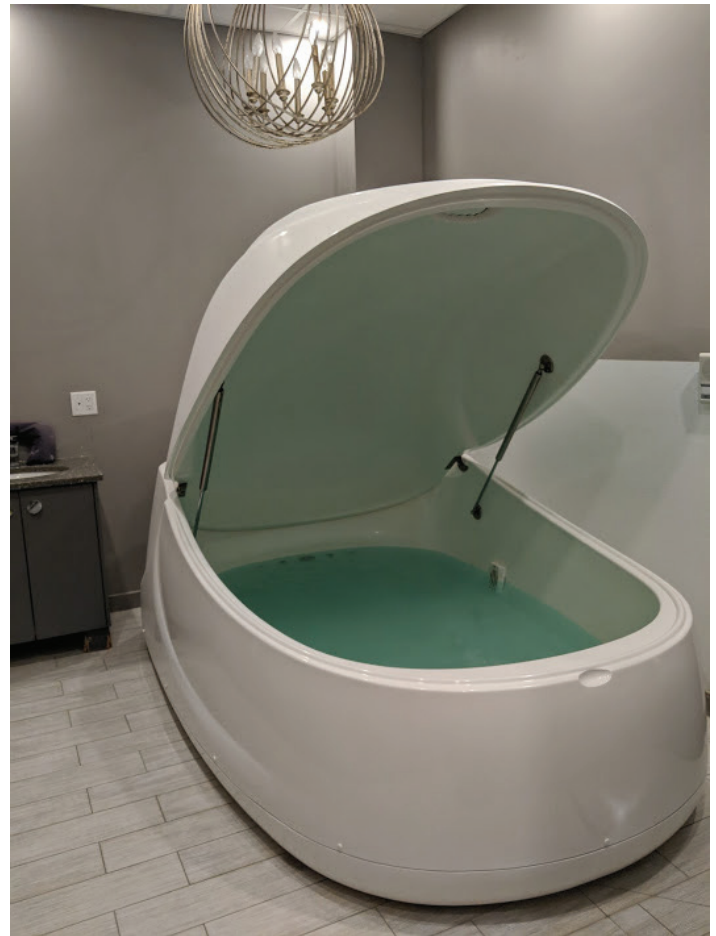
Fig. 1: Floatation Tank. Photo taken by K. Rehbein Oct 2018.

As a condition of the Public Health Act Order, the operator of the floatation tank was directed to undertake repairs of the floatation tank's mechanical system, thoroughly clean and disinfect the floatation tank and its re-circulation system, change the filter, develop equipment maintenance and water monitoring records, ensure stabilization of water chemistry, and provide training to staff. Super-chlorination of the floatation tank (increased concentration of free available chlorine to >10 ppm) and the recirculation system piping was conducted several times by the operator. The filter was changed multiple times, repairs were made to the malfunctioning equipment, comprehensive checklists were developed, and the operator achieved a much greater understanding of floatation tank operation. Additionally, the operator attended compliance meetings with EHOs at Vancouver Coastal Health. It was impressed upon the operator that the reservation system must reflect when a floatation tank is out of service to ensure that this type of error does not happen again. The operator acquired new testing equipment and implemented a policy requiring staff to measure and record water chemistry parameters before each floatation tank user. When all the requirements had been satisfied, a follow-up water bacteriology sample was taken, which tested negative for *Pseudomonas aeruginosa*. The Closure Order was lifted on 16 February 2018.

It was noted by the operator that this floatation tank was designed to have an automatic chlorination system that was originally designed for hot tubs. Automatic chlorination systems for hot tubs have been designed to chlorinate larger volumes of water and are not well suited to small, single-person floatation tank designs. The operator explained that when operating a floatation tank with an automatic chlorinator designed for a hot tub, it is very difficult to maintain a free chlorine residual of <10 ppm even on the lowest setting. Auto-dosers, which dispense too much chlorine, make it extremely difficult to achieve a safe concentration of chlorine per volume in floatation tanks. This can lead to operators turning off the automatic chlorinator resulting in zero residual. Equipment incompatibility may lead to increased frequency of equipment failures and an increased likelihood of inadequate or excessive chlorine concentrations. The industry needs to develop automatic chlorination systems that are specific to floatation tanks.
